Fuller Brook Park Preservation Project – Phase 3
Final Design & Permitting
Wellesley, MA

Special Studies
Executive Summary

August 23, 2012

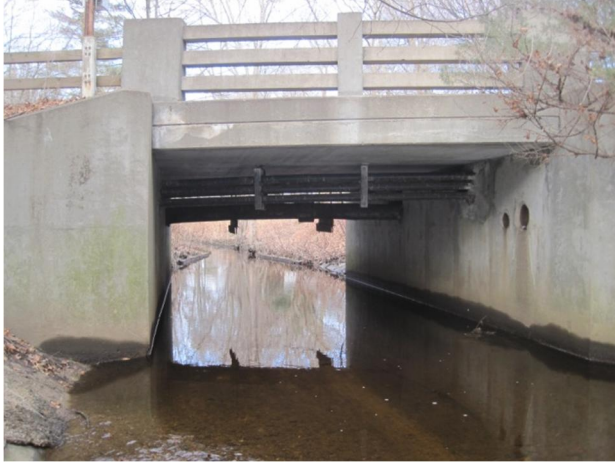
Photo 1: Cottage St. culvert with utilities

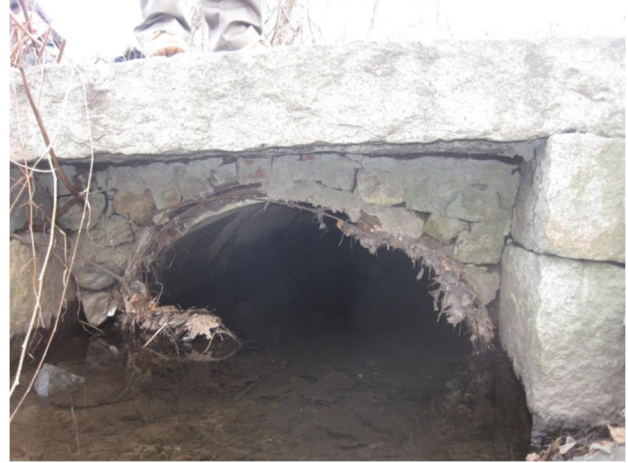
All culverts including headwalls and wingwalls are generally in good condition, except the 48-inch diameter RCP culvert for the footpath off Smith Street, which is deteriorated and steel reinforcing is exposed (Photo 2). It should be noted that the bottom of the culverts on the lower portion of Caroline Brook were not observed due to being submerged and partially filled with sediment.

Photo 2: Footpath culvert off Smith Street

3. Medium Priority – Recommended project improvements - Not in scope of work
- 3.1. Repair/replace or remove footpath culvert off Smith Street to Hunnewell Field. This culvert is in fair to poor condition and may not be necessary with new path system. (HA)

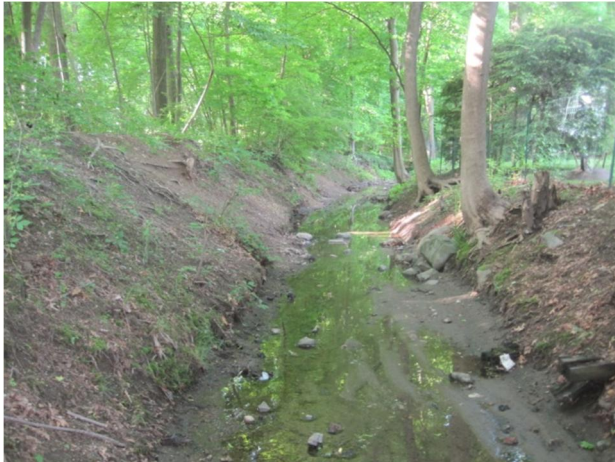
Photo 3: Steep, poorly vegetated slopes along upper Caroline Brook

Stream bank erosion for upper Caroline Brook from Caroline Street to Forest Street is due primarily to the lack of vegetation on the banks (Photo 3) and lack of natural sinuosity³ in the brook; the brook is severely channelized across this reach. Abutting owners have installed railroad ties and stone as an attempt to prevent additional property loss.

- 1.7. General maintenance/repairs to repoint mortar stone and block walls for culvert/bridges. (HA)
 - 1.8. Install stream bank stabilization measures for the eroding stream sections described below and shown on the Special Studies Recommendations Plans. Both hard and soft stabilization measures are recommended based on the results of the hydraulic analysis. Hard stabilization techniques include concrete, riprap, gabions or other engineered hard structures. Soft stabilization techniques include vegetation, coir logs, coir blankets, or other natural practices. (HA)

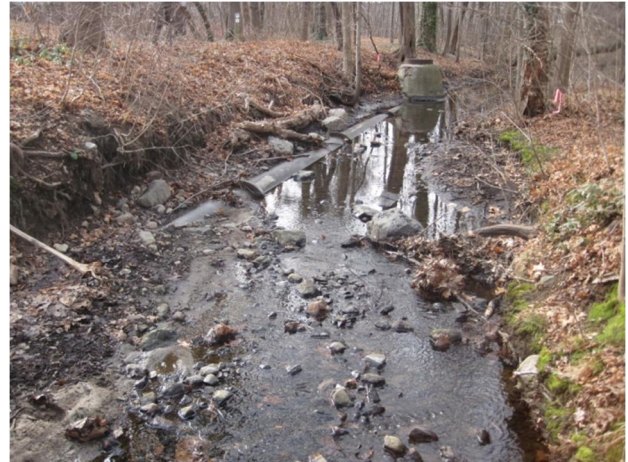
Photo 4: Erosion exposes sewer infrastructure down gradient of Forest Street

The most severe signs of stream bank erosion are observed downstream of the Forest Street culvert. Poor culvert alignment, steep gradients, and elevated shear stresses have contributed to the exposure of the adjacent sewer infrastructure. The risk of sewer line failure at this location is

high given the current conditions (Photo 4). A second section of abandoned sewer pipe is also exposed just up-gradient of the confluence of Cold Spring Brook.

- 4.2. Any future upgrades to the Forest Street culvert should also include improving culvert alignment and decreasing the culvert slope as necessary. These improvements will help to reduce erosion and risk of sewer failure. (HA)

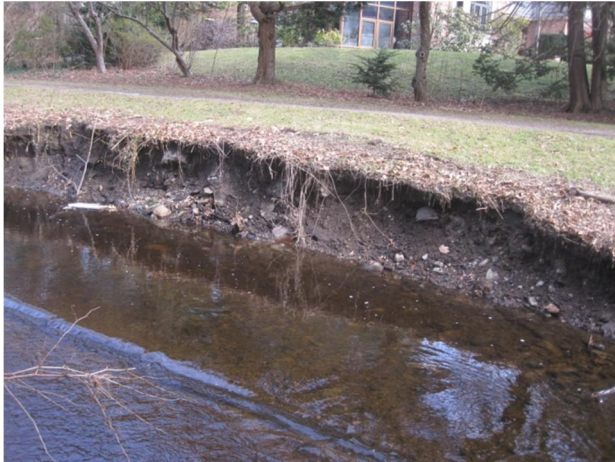
Due to attempts over the years to straighten, lower, and generally increase the capacity of Fuller Brook, most of the natural banks and stream bottom have been impacted. The disturbance and straightening of the brook, in addition to increased development within the watershed, causes velocities and flows to increase which in turn, contributes to erosion (Photo 5) and changes in brook shape. This can be seen throughout the section of Fuller Brook to varying degrees, most significantly around locations of drainage outfalls and concrete liners (Photo 6).

Photo 5: High shear stress cause erosion of stream bank

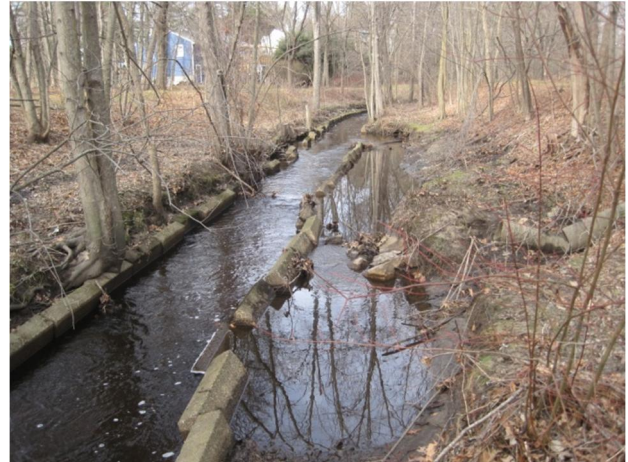
Photo 6: Erosion outside concrete liners

- 1.6. Provide improvements to drainage outfalls to repair and protect against erosion. Evaluate opportunities to re-use concrete liners within the project, possibly for energy dissipation at drainage outfalls and/or to create riffle-pool sequences within the stream channel. (HA)

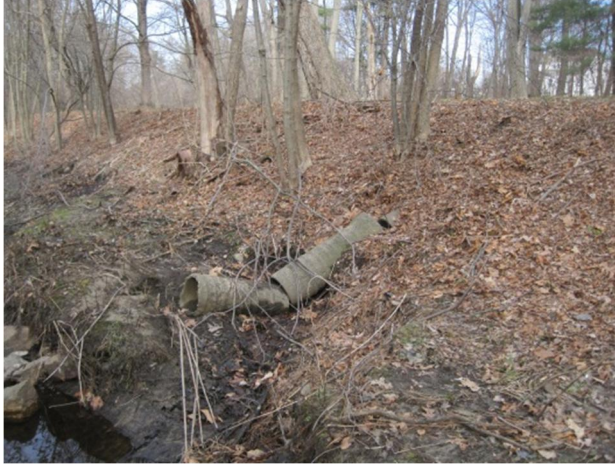
Photo 7: Erosion undermines drainage outfall

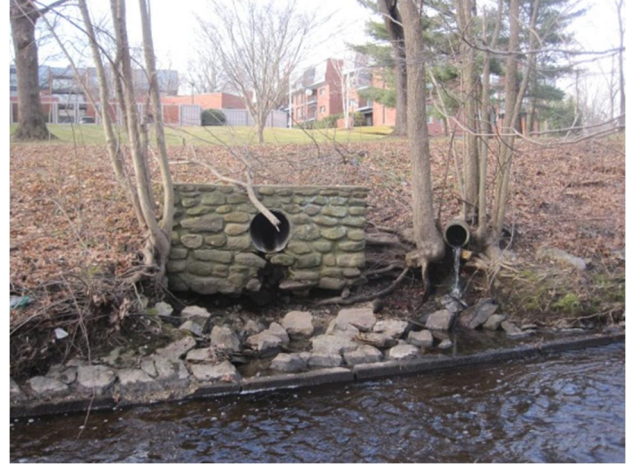
Photo 8: Headwall undermined & trees disrupt outfalls

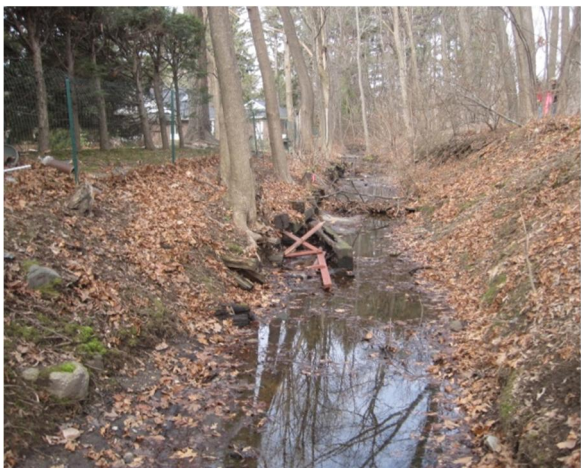
1. Stream Bank Erosion: Caroline Brook through Section 1 has a high canopy of tree cover but little in terms of vegetated ground cover. Banks are steep (Photo 9) and susceptible to erosion from stormwater runoff from adjacent land as well as from stream flow from significant storm events. Erosion material from steep banks and areas of high shear stress identified in the Hydraulic Analysis Report deposit eroded material to down gradient sites where velocities and stresses are lower. In general, channelization of the brooks for flood control and upland development has caused the brooks to become “flashy” stream systems. This means that stream flows rise and fall quicker and to higher elevations during and after storm events than in a natural system where runoff is infiltrated and

Photo 9: Erosion of steep stream bank

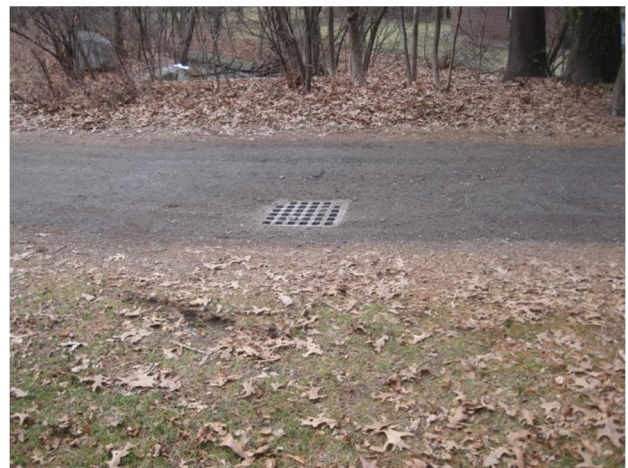
2. **Exposed Soil:** Caroline Street is a gravel road (approximately 500 feet in length) where it crosses the park (Photo 10). Stormwater runoff from the road is collected in catch basins, which discharge directly into the headwaters of Caroline Brook via a drain pipe and headwall. Exposed soils during construction periods can also be a problem if not maintained with proper erosion and sedimentation control (ESC) measures. The ongoing construction at the Wellesley High School, as well as any other site in the watershed, should be carefully monitored, and ESC measures should be installed and maintained as necessary.

Photo 10: Gravel & catchbasin in Caroline St

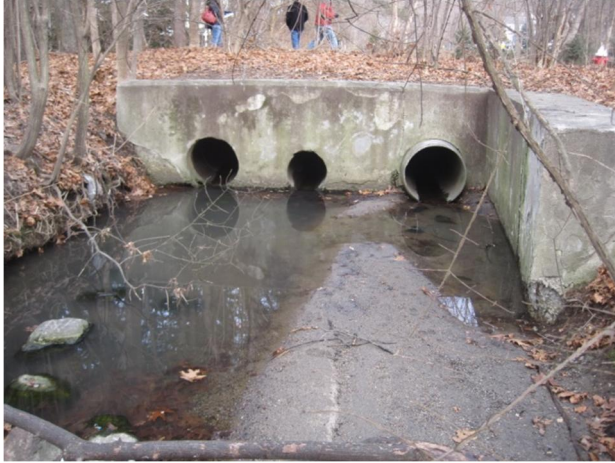
3. **Stormwater Runoff:** As mentioned above and like many communities with older municipal drainage systems, stormwater runoff is directed to surface streams with little to no prior treatment. The brooks have essentially been used as part of the stormwater management system for a major portion of the Town streets. They have been modified several times over the last century to primarily provide better flood control for the center of town. Catch basins and pipe systems collect and discharge stormwater runoff from streets, yards, and parking lots to the brooks. Not only does this increase peak flows to the stream as discussed above, but it also has little to no capability to provide effective capture and removal of sediments and other stormwater pollutants (Photo 11).

Photo 11: Wellesley Square drainage systems outlet at Caroline Street Headwall

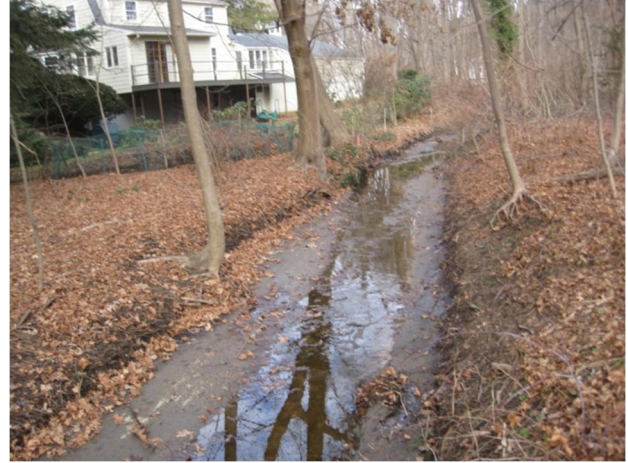
Photo 12: Sediment deposits in Caroline Brook

Sands and other debris are deposited where stream velocities are slow enough for them to settle out. This can be clearly seen at the headwall at Caroline Street. Once the sediment levels in the brook exceed the available storage capacity, sediment is then transported to the next settlement area, and the process repeats itself until equilibrium is established. Excessive sedimentation has reduced the brook's capacity to convey runoff and ability to attenuate stormwater during periods of high runoff, often resulting in property damage and/or dangerous flooding conditions. In addition, Fuller Brook is listed by Massachusetts Department of Environmental Protection (MADEP) as an impaired waterway for pollutants; organic enrichment/low dissolved oxygen and siltation, and has a total maximum daily load (TMDL) for pathogens.

1. Highest Priority - Recommended project improvements – In scope of work (present in no particular order).
 - 1.1. Dredge Caroline Brook stream bed from Caroline Street to Forest Street to remove accumulated sediments, including two tributary swales. (HA & SI)

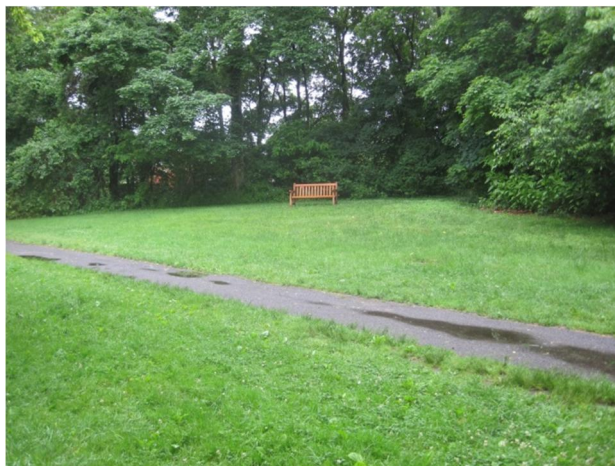
Photo 13: Looking south toward Cold Spring Brook

This is predominately an open grass area sloping 5-6% toward Fuller Brook from elevation 128 to 122 feet, while the southern edge slopes to Cold Spring Brook. The small 0.5± acre contributing drainage area primarily only includes the park area and portions of the abutting condominium property to the west. Some areas of standing water were observed (Photo 14) in the paved path after rain events, but no standing water was observed in the remaining park area. Data from the hydraulic analysis for this segment indicate flooding is not an issue until the 10 year frequency storm event.

Preliminary plans for this project include realigning the path and creating two wet meadow areas, one on either side of the path (See Wetland & Seasonal Inundation Analysis Fuller Brook Plan).

See Recommendations Plans for proposed areas of hard stabilization, combination of soft and hard stabilization, and soft stabilization.
 - 1.9. Cold Spring Brook to Brook St. area: Realign the path as proposed and construct an upland meadow community in the locations previously proposed as wet meadows. (WSIA)

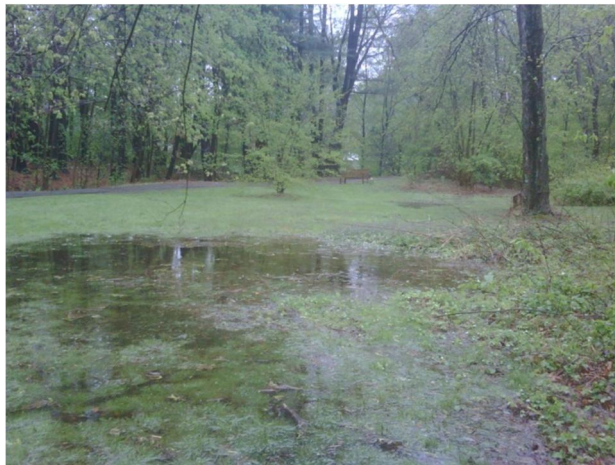
Photo 15: Looking south between Wellesley Ave & Brook St

This area is a mixture of woodland and lawn area with large trees. The path along the west side of the brook creates a partial barrier, preventing some overland flow from reaching the brook. Two pipe culverts, a 12-inch RCP and an 8-inch clay pipe, were installed to direct accumulated water in this area to the brook. Although the Town mows the lawn area, portions are delineated as bordering vegetated wetland (BVW), and were included in the approved Order of Resource Area Delineations (ORAD) for this project. Ponded water was observed in the BVW lawn area as much as 8 inches deep after rainfall events (Photo 15). Hydrologic data indicates that the brook overtops the path during the 10-year storm event. Data from the hydraulic analysis for this segment indicate flooding is not an issue until the 10 year frequency storm event.

Preliminary plans for this project include realigning the path to the west and creating a wet meadow area along the bank of the brook (See Wetland & Seasonal Inundation Analysis Fuller Brook Plan).

- 1.10. Brook St. to Wellesley Ave. area: Realign the path as shown on the Special Studies Recommendations Plan (Sheets 7 & 8), incorporating an elevated walk section where wetland crossing occurs. The existing 12-inch drainage pipe would be removed since the walk would span the wetland areas, maintaining hydrologic connectivity between the wetlands and the brook. Construct a wet meadow habitat community with the bottom at elevation 123.2 to 123.7± feet by expanding along the existing wetland boundary and planting additional native herbaceous wetland species. Create a diversified habitat within the proposed wet meadow area by excavating to approximately elevation 122± feet. Areas north of the pathway should be planted with woody vegetation to enhance and expand the existing wooded portions of the wetland without the need for excavation. (WSIA)

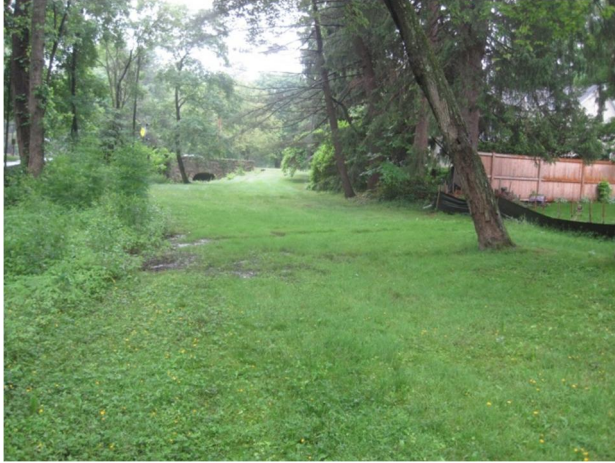
Photo 17: Looking south toward Wellesley Ave

This section on the west side of the brook is a low-lying mixture of mowed lawn with a high canopy created by large trees with, and vegetated areas primarily adjacent to the brook. The land varies in slope from 1-6% toward Fuller Brook, from elevation 126 to 123 feet. The 1.5± acre contributing drainage area includes the residential lots on the east side of Aberdeen Road. Some areas of standing water and saturated ground behind house numbers 5, 13 & 15 Aberdeen Road were observed after rain events. Data from the hydraulic analysis for this segment indicate flooding is not an issue until the 10 year frequency storm event.

Note that the path is located on the east side of the brook (i.e., not in the area where wet meadow is being proposed). Preliminary plans included creating two wet meadow areas along the west bank of the brook (See Wetland & Seasonal Inundation Analysis Fuller Brook Plan).

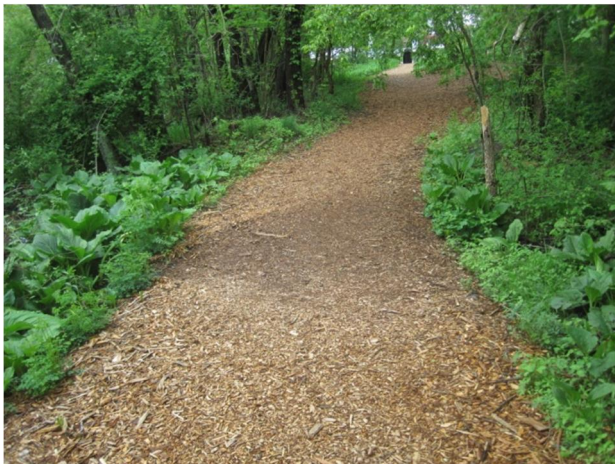
The path in this area is only ~12 inches higher in elevation than the adjacent wetlands areas. The three 8-inch clay pipe cross culverts are either partially or completely buried/blocked, preventing flow from the western wetland area from reaching the brook. During most rainfall events stormwater flow saturates and often overtops portions of the path at the culverts (Photo 19) and both ends of the boardwalk (Photo 20).

Photo 19: Stained wood chips where flow overtops path at clogged culverts

- 2.4. Install new, higher outlets for Marvin Road drainage system. (HA)
 - 2.5. Paine St. Swamp area: Address additional saturated path sections not previously identified in the preliminary plans by removing damaged/blocked culverts and fill material; restoring the disturbed wetland; and installing two 20± feet boardwalk/bridge sections at low areas to re-connect wetland areas and allow unrestricted flow. (HA & WSIA)

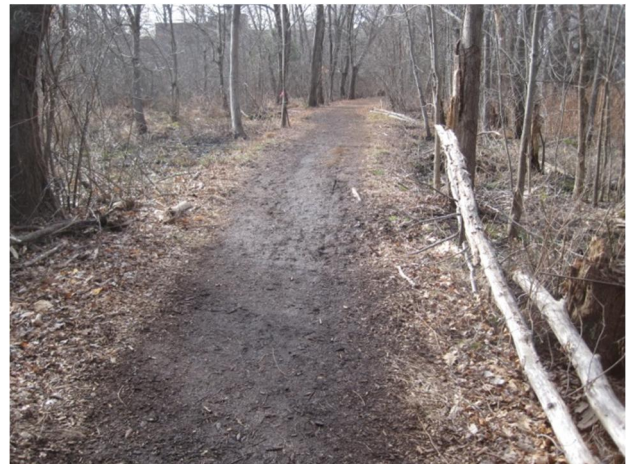
Photo 20: Saturated path at end of existing boardwalk

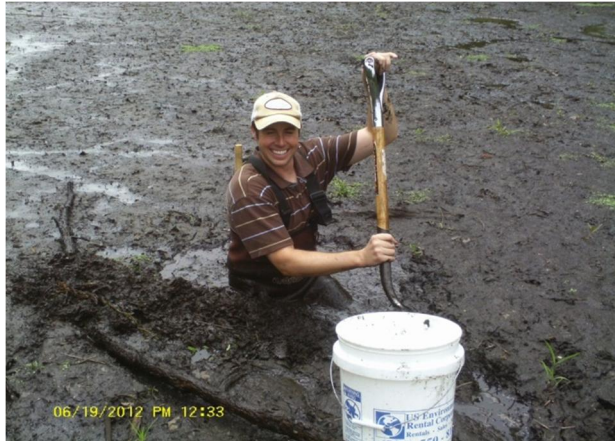
A highly organic sediment was found in the State Street Pond at depths ranging from approximately 1-3 feet. This sediment extended above the water line in some areas of the Pond. Beneath the organic-peat is a fine, grey, silty-sand. Fuller Brook was observed to have a smaller thickness of the sediment material mixed with a fine to coarse sand from 0-8", followed by a grey silt.

Photo 21: Organic Material State St Pond

- 1.13. An estimated 50% of the sediment material from the State Street Pond will be able to be relocated in town, provided that it meets the anti-degradation provisions of the MCP, 310 CMR 40.032(3). Specifically, it is not to be re-used at a location which would trigger a reporting condition or where the concentrations of existing contaminants at the proposed location are significantly lower than the material being relocated. (SS)

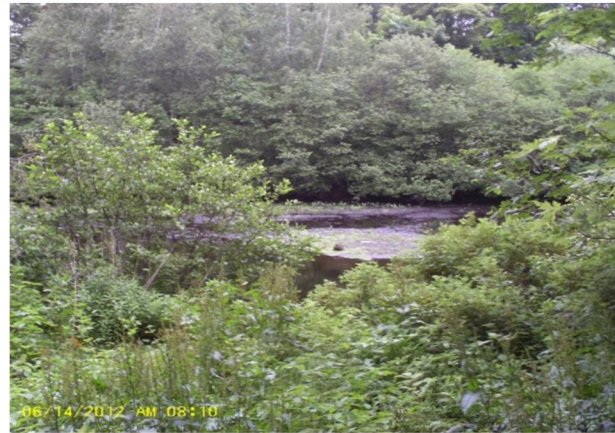
Photo 22: Sediment observed at surface of State St. Pond

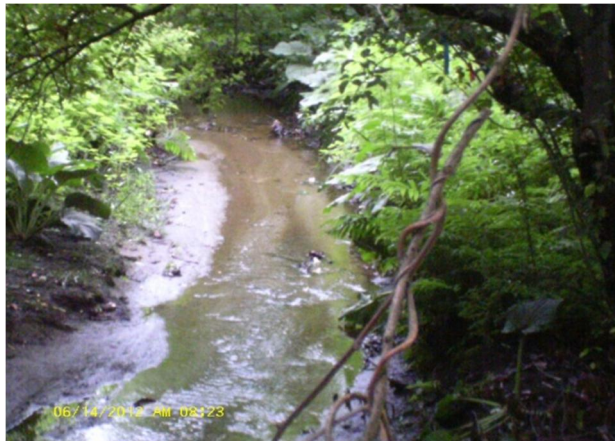
Photo 23: Between Rice St & Paine St.

A sediment material similar to the State Street Pond was observed in lower Caroline Brook to depths of approximately 3 inches, followed by a fine to coarse sand and small gravel. Organic fibers, including mulch/tree bark, were noted in some samples.

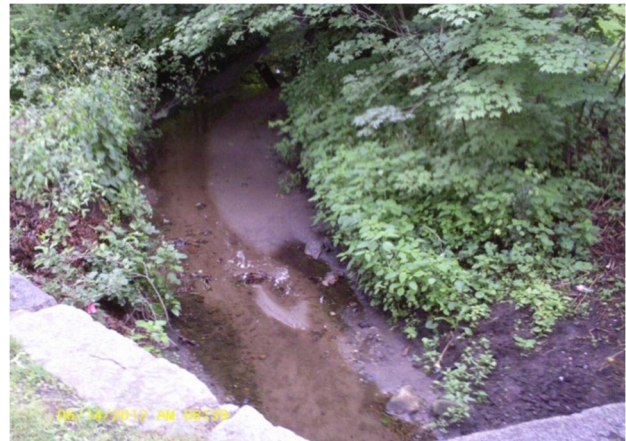
Photo 24: At inlet to Forest Street culvert

Trace organics and peat was observed in Upper Caroline Brook from 0-6". Fine to coarse sand and gravel was noted to depths of 18".
